NASA TM X-1119

INVESTIGATION OF ATLAS SOLID  
FUEL RETARDING ROCKET DURING  
ATLAS-CENTAUR SEPARATION TESTS

*by Richard W. Heath, Henry Synor,  
Ralph F. Schmiedlin, and John H. Povolny*

*Lewis Research Center  
Cleveland, Ohio*

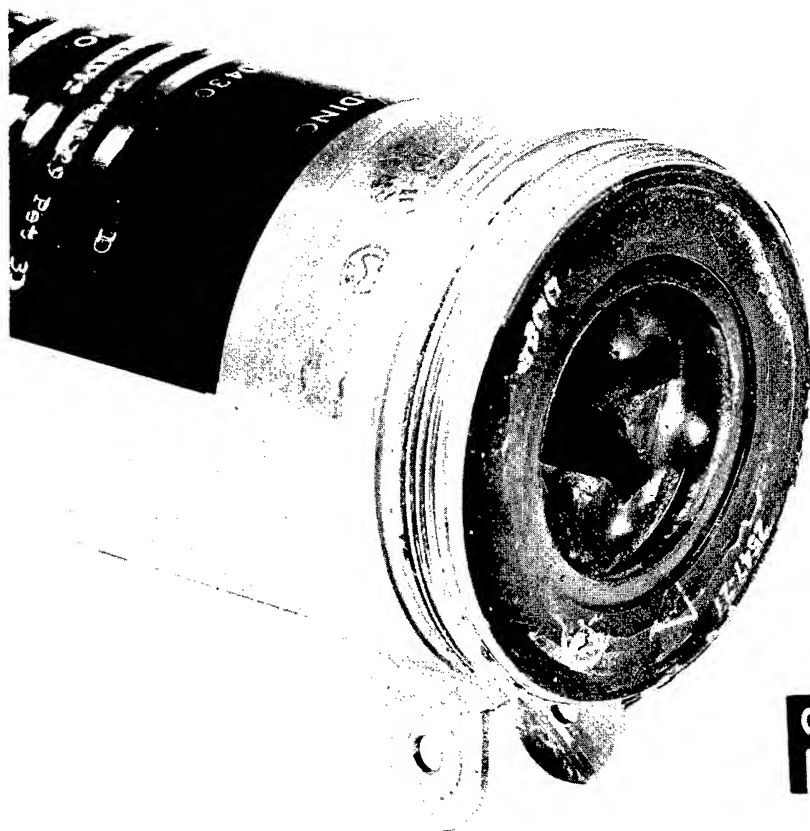
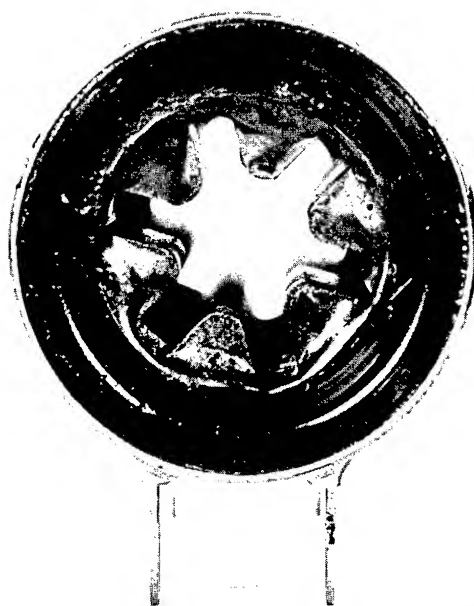
Figure 4. - Grain of misfired rocket.

Of the 67 units fired, 6 misfires were encountered when Ordnance Associates igniters were used. Examination of the misfired units revealed that the grain was intact, the nozzle diaphragm (which was in accordance with the flight configuration) when used was ruptured and partly extruded into the nozzle, and the igniter was fired with no part of its "propellant" to be found in the rocket (figs. 4 and 5). The characteristic pressure record from a misfired motor is an abrupt pressure rise to approximately 250 to 450 pounds per square inch, after which a rapid decay ensues (fig. 6).

(a) Viewed from nozzle end.

(b) Viewed from igniter end.

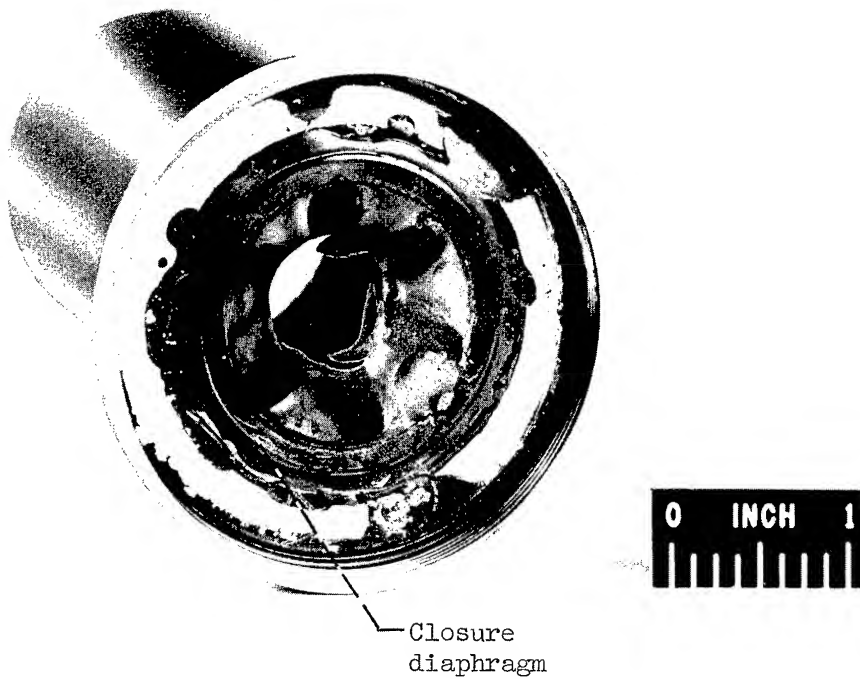
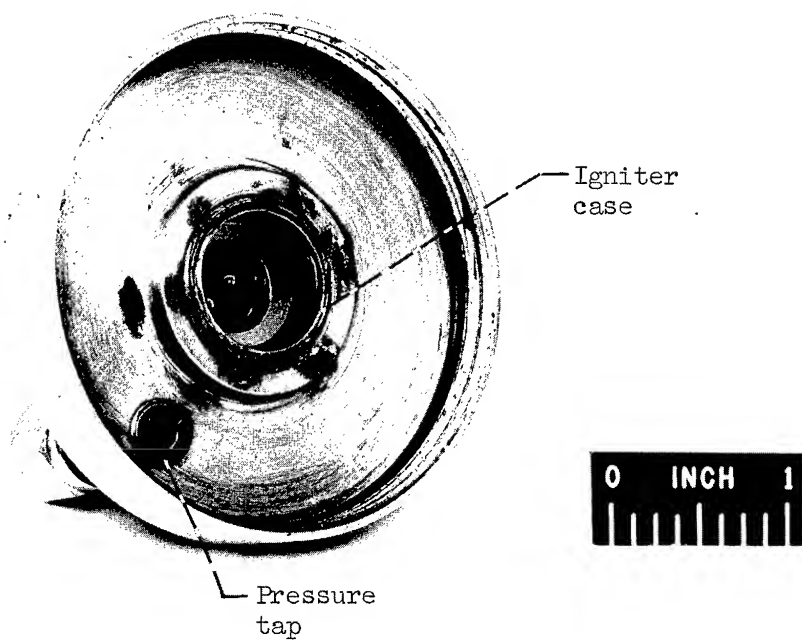
Figure 5. - Misfired rocket.

(a) Nozzle showing ruptured diaphragm.

(b) End cap showing expended igniter.

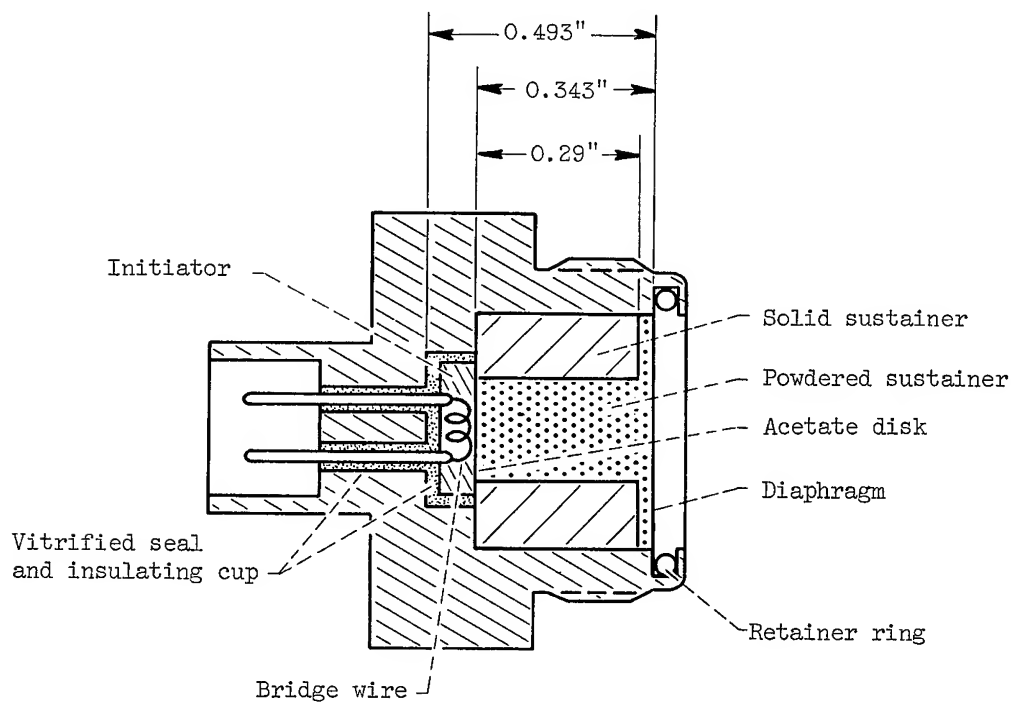
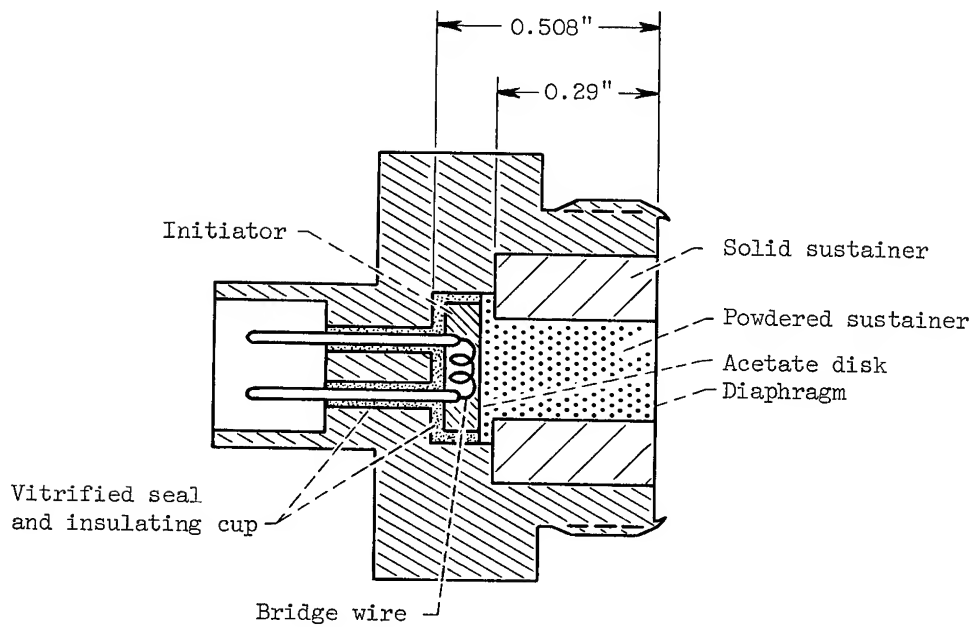
Figure 7. - Igniter configuration; P/N OA-A8, Ordnance Associates, Inc.

It was noted initially, and supported by subsequent firings, that the igniters in all misfired rocket engines using Ordnance Associates igniters (except for one special test) were from production lot 3-2 (table I). Investigation revealed that the configuration of the igniter (P/N OA-A8) had not been maintained constant; several internal configurations had been used in the igniter with changes made from one lot to the next (fig. 7). The changes from lot 2-1 to 3-2 include (1) the omission of the retaining ring at the igniter exit, (2) a decrease in the depth of the initiator cavity and elimination of a cavity at the exit of the unit, and (3) a repositioning of an acetate disk below the solid sustainer, which created a new cavity containing powdered sustainer.

(a) Production lot 2-1.

(b) Production lot 3-2.

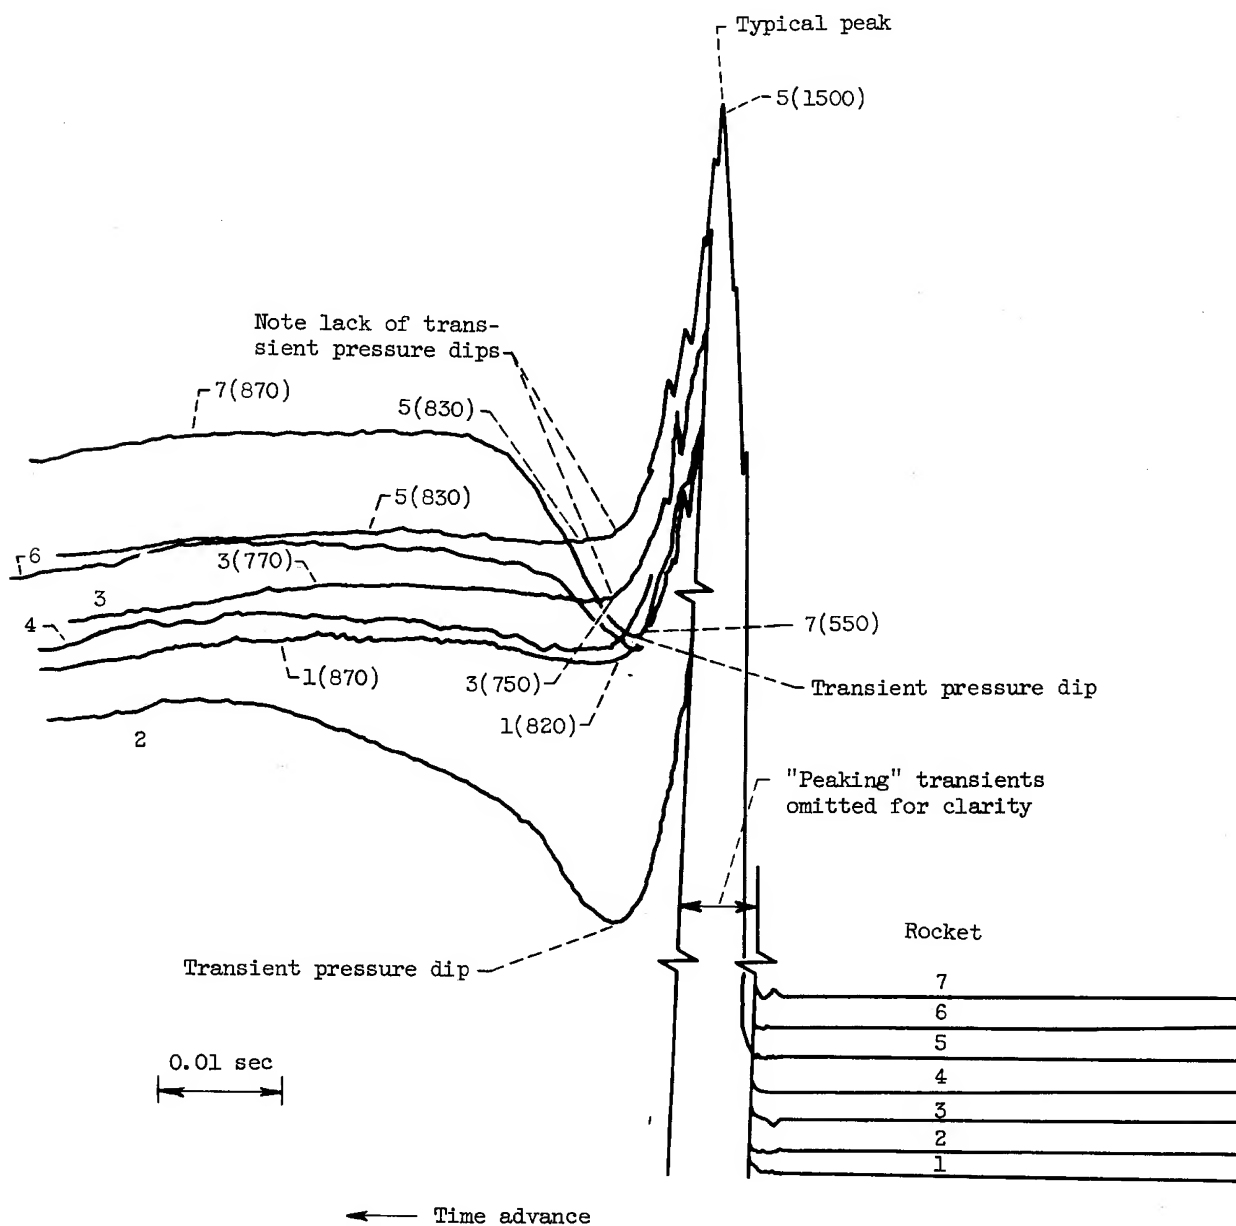
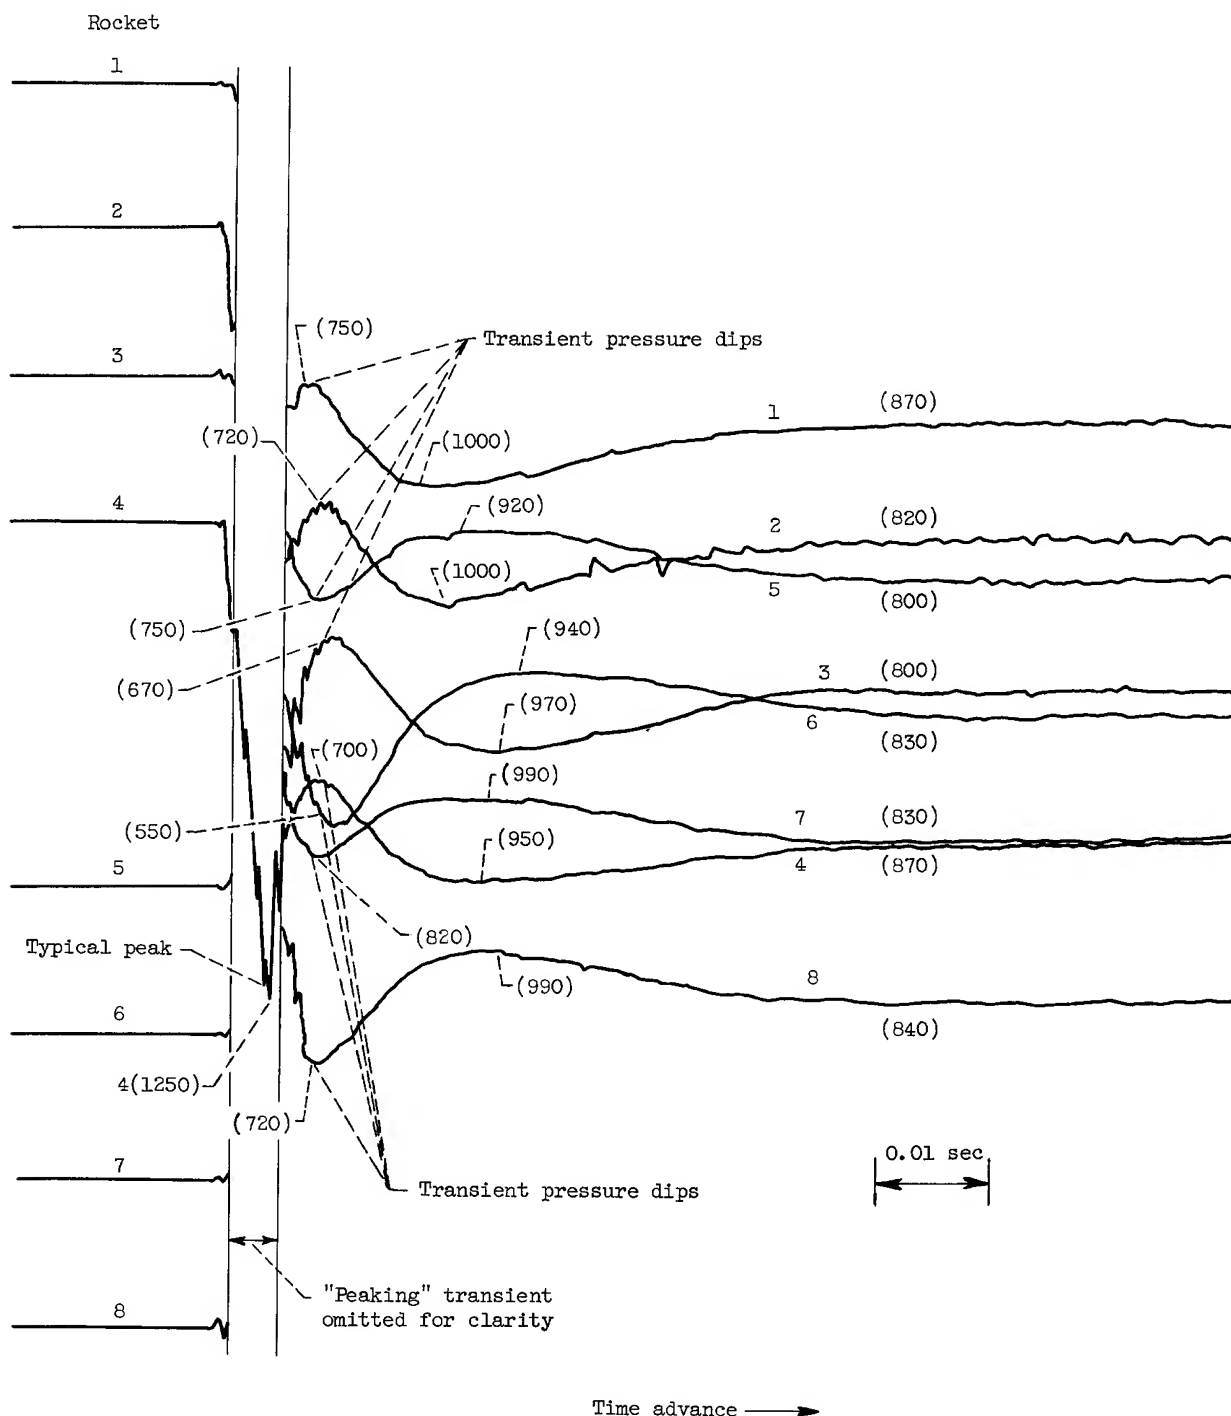
Figure 8. - Pressure records of incipient rocket failures. Numbers in parentheses are peak pressures and pressure dips in psia.

Pressure traces obtained in the test firings were scrutinized in an effort to discover any apparent inadequacies in the ignition cycle which could be related to the igniter changes. In several instances an abnormally low chamber pressure occurred between the ignition peak of approximately 1500 to 2000 pounds per square inch and the steady-state burning pressure (fig. 8(a)). In order to understand this occurrence, eight rockets having lot 2-1 igniters were fired with a 1/8-inch hole drilled through the nozzle closures so that the chambers were at a near vacuum condition prior to firing. The pressure traces from this test firing, which are shown in figure 8(b), revealed that each engine experienced a pressure falloff similar to that mentioned earlier although not quite as severe. The generation of the falloff, or saddle, in each instance is felt to demonstrate a susceptibility of the igniter to an initial low-pressure condition in the combustion chamber and to give an indication of inadequate performance margin. The pressure falloff probably results from the propellant grain not being sufficiently ignited at the time of igniter burnout and could probably be eliminated with the use of a longer burning igniter. While these tests did serve to uncover a marginal performance characteristic, they did not explain why lot 3-2 igniters produced misfires and lot 2-1 igniters did not under normal conditions.

(a) Random failures.

(b) Consistent failures.

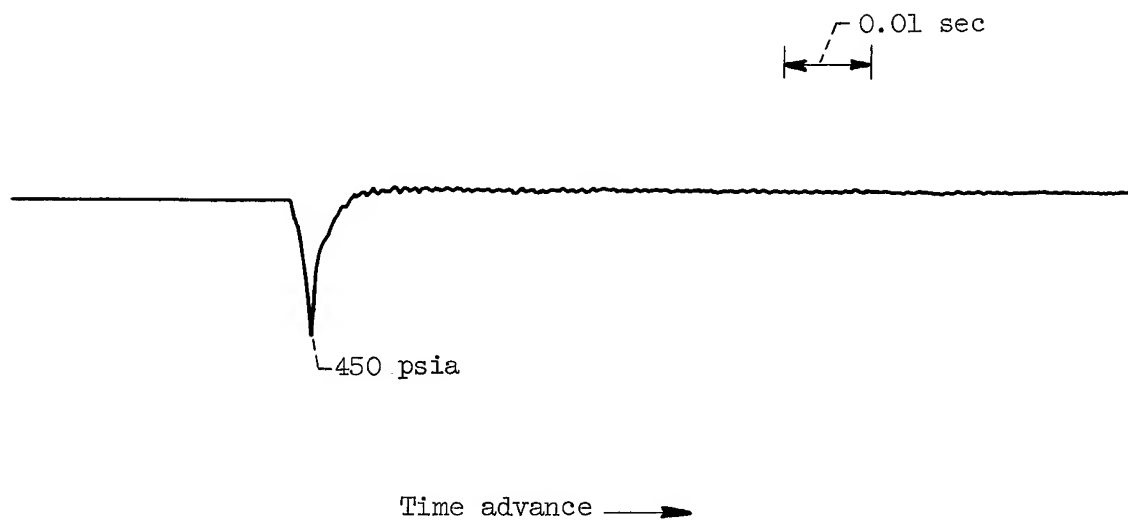
Figure 9. - Pressure record of lot 3-2 igniter fired into live rocket with no closure diaphragm.

In an effort to determine how much the margin of performance could be reduced before the engine refused to fire, two rockets were tested with no nozzle closures, one with a lot 3-2 igniter (fig. 9) and one with a 2-1 igniter. Both failed to ignite the rockets at the altitude condition, which confirmed that the limits of reliable operation had been exceeded. Although the ability to ignite the propellant grain successfully under vacuum conditions and with no nozzle closure is a more severe requirement than encountered during flight, it is felt that this test further illustrates the lack of adequate margin in the combination of the Ordnance Associates, Inc., igniter and the Rocket Power, Inc., rocket.

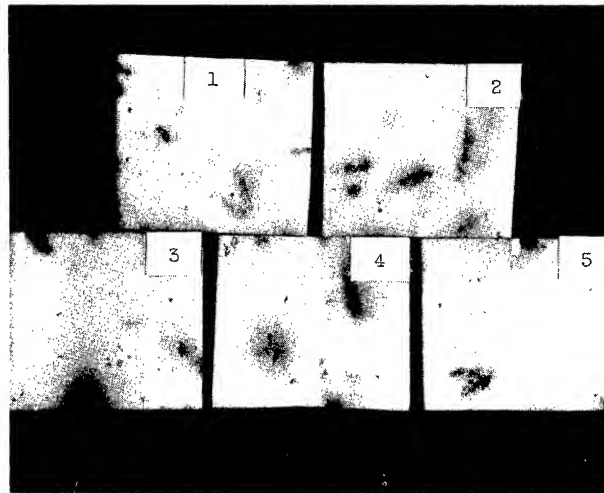
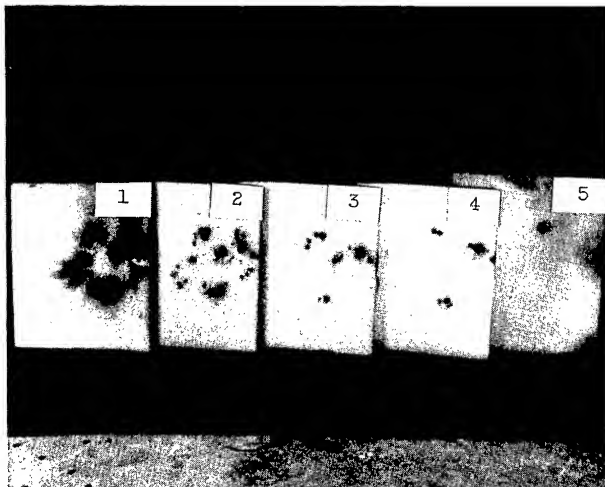
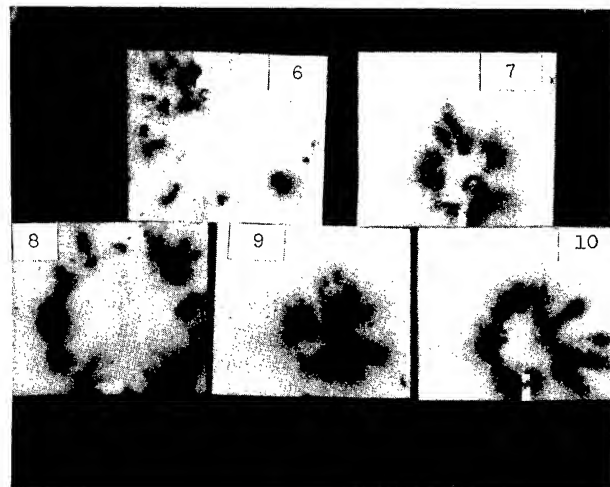
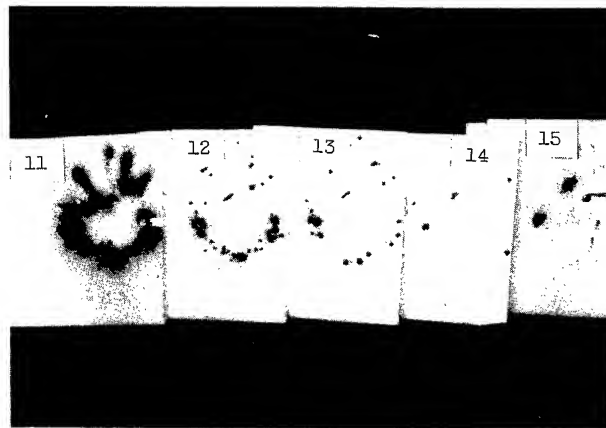
Figure 10. - Flame impingement patterns.

Some tests were conducted by Beckman and Whitley Laboratories to determine what had caused the 3-2 igniters to lose all their margin of performance. Both the lot 3-2 igniters and the lot 2-1 igniters, which had no record of misfires, were fired into Styrofoam blocks to make a record of flame-impingement patterns. Their findings, noted in references 1 and 2, reveal that the lot 2-1 igniters consistently displayed a widely dispersed flame pattern, while the lot 3-2 igniters were inconsistent. The 3-2 units occasionally fired an extremely narrow and concentrated flame front (fig. 10). This characteristic leads to the theory that the lot 3-2 igniters when their discharge pattern is concentrated do not impinge on the grain surface sufficiently and, therefore, may not impart enough heat into the grain to cause ignition. This inconsistency in performance may be inferred to result from the previously described changes in the igniter's geometry. The combination of an initial low performance margin and an inconsistent flame discharge pattern is apparently sufficient to cause occasional ignition failures. Supporting this conclusion are data obtained at Lewis from the firing of two igniters manufactured by Librascope (fig. 11) whose constituents were described earlier. The first igniter firing at sea-level ambient pressure was made into a Styrofoam block, and a narrow impingement pattern was observed (fig. 12). The second firing, at a 98 000-foot-altitude ambient pressure, involved the installation of a Librascope igniter in a Rocket Power, Inc., rocket from which the nozzle closure had been removed. The igniter failed to ignite the rocket propellant, as would be anticipated from the flame pattern.

(a) Lot 2-1 igniters. Note widely dispersed patterns.

(b) Lot 3-2 igniters. Note narrowly dispersed patterns in 1, 7, 9, and 11 and widely dispersed patterns in 4, 5, 6, 8, and 14.

The specific causes for the marginal performance appear to be (1) an inadequate igniter burning time aggravated by (2) inconsistent igniter discharge patterns, which occasionally did not impinge on the rocket propellant grain. Therefore, it is desirable to substitute an igniter which (1) burns till the rocket grain is sufficiently ignited, and (2) directs its flame pattern positively towards the grain surface. *— end*

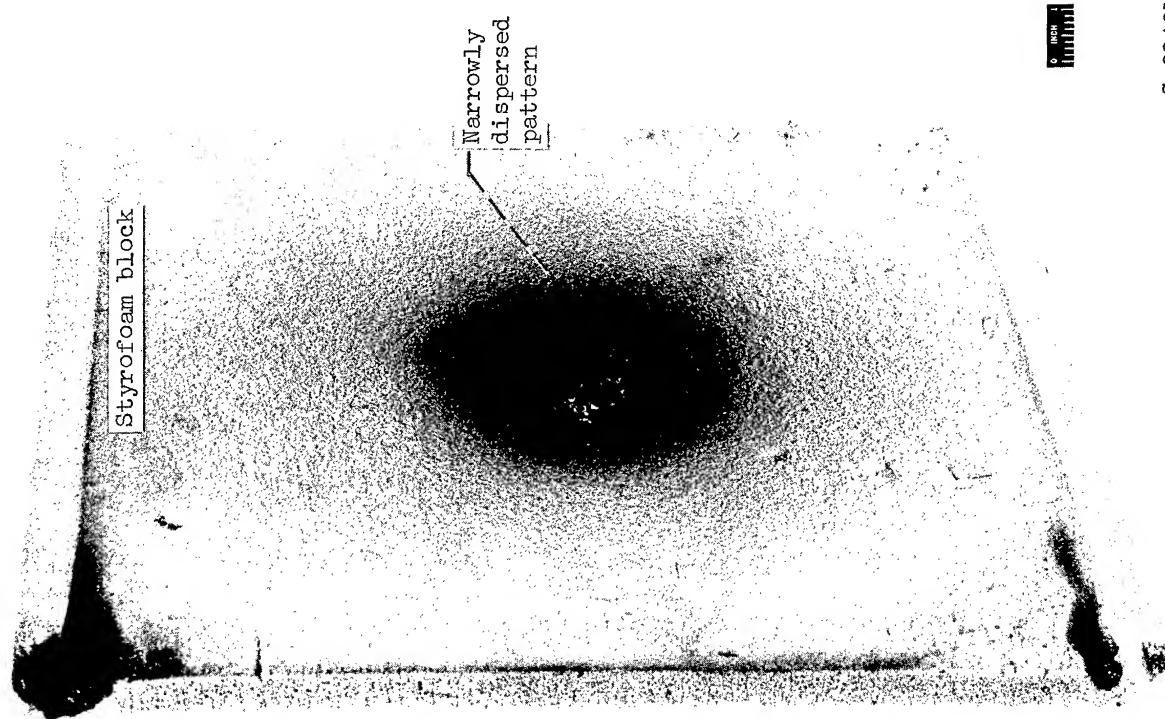
Figure 12. - Flame impingement pattern of Librascope igniter.

Narrowly  
dispersed  
pattern

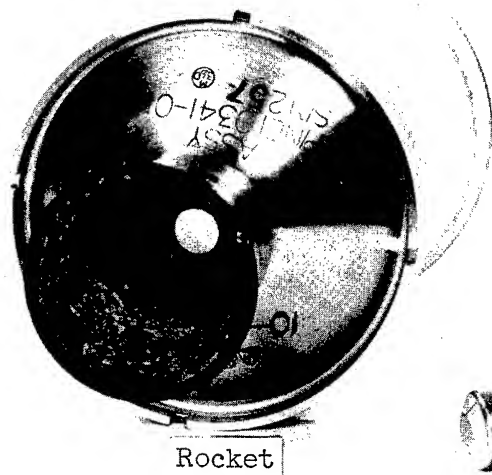
Figure 13. - Thiokol igniter TE 350 with rocket 2.41 KS 513 for which it was designed.

In order to further substantiate the theories concerning flame direction and igniter burning time outlined, a test was made at a pressure altitude of 98 000 feet with a Thiokol Chemical Corp. igniter (fig. 13), installed in Rocket Power, Inc., rocket having no nozzle closure. This igniter burns for a longer period of time (0.25 sec compared with 0.004 sec for the Ordnance Associates igniter) and directs the flame pattern at the rocket grain. The longer burning time is effected primarily by an increase in the igniter's constituent mass. The increase in the mass, with its resultant increase in heat content and burn time, coupled with the directed flame pattern tended to ensure that the rocket grain would receive sufficient heat to ignite. Successful ignition of the rocket propellant occurred (fig. 14).
